**SCREENING SITE INSPECTION
SITE EVALUATION
GRANVILLE SOLVENTS, INC.
PALMER LANE P.O. BOX 95
GRANVILLE, OHIO 43023**

U.S. EPA ID NO.: OHD 004 495 412

U.S. EPA Work Assignment No.	:	29-5JZZ
U.S. EPA Region	:	5
Date Prepared	:	November 29, 1993
Contract No.	:	68-W8-0084
PRC Project No.	:	030-002966
Prepared by	:	PRC Environmental Management, Inc. (Chris Cappel)
PRC Project Manager	:	Julie Kaiser
Telephone No.	:	(312) 856-8736
U.S. EPA Work Assignment Manager	:	Jeanne Griffin
Telephone No.	:	(312) 886-3007

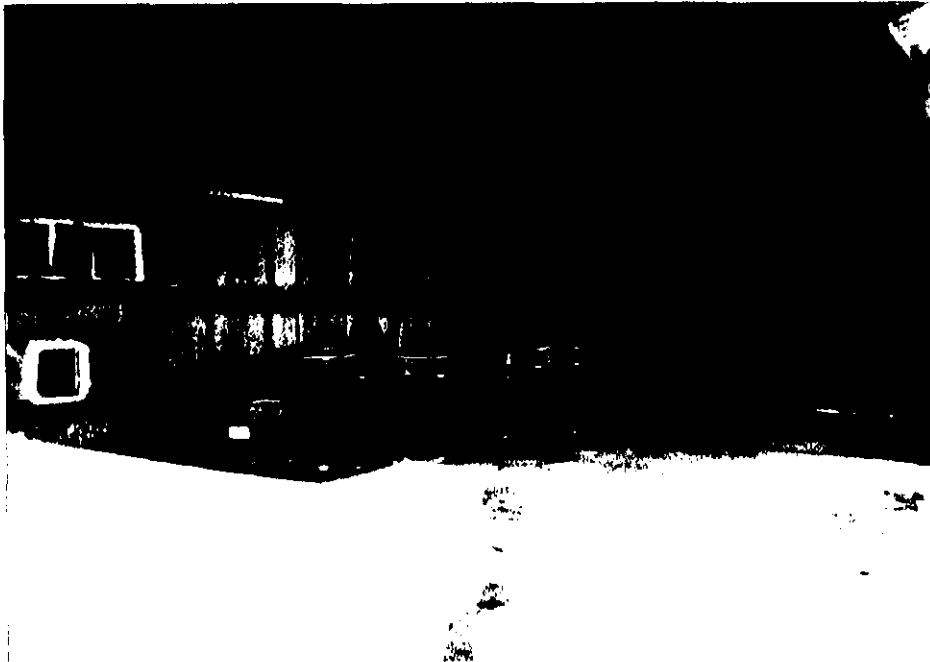
Photograph No. 2

Description: West entrance and inside of warehouse; drums shown on north side of building are empty

There are three buildings on site. The largest is 40 feet by 48 feet and is constructed of galvanized metal siding supported by a wood and metal frame anchored on 10 concrete piers (see photographs No. 2 and 4). The floor consists of 4-inch-thick reinforced concrete slabs. Access to the building is gained through two large sliding doors on the east and west walls, and two smaller loading doors on the south wall (see photographs No. 2 and 3). This building is referred to as the warehouse and was used for GSI's manufacturing operations and for storage. The warehouse's floor has a small, unlined pit that is about 3 feet deep near the building's northeast corner (see photograph No. 3), which is thought to be a source of groundwater contamination (OEPA 1991c), has also been referred to as a sump. There is a second unlined depressed area in the warehouse floor in the northwest corner. Pipes leading to the former tank farm entered the building in this corner (PRC 1993a).

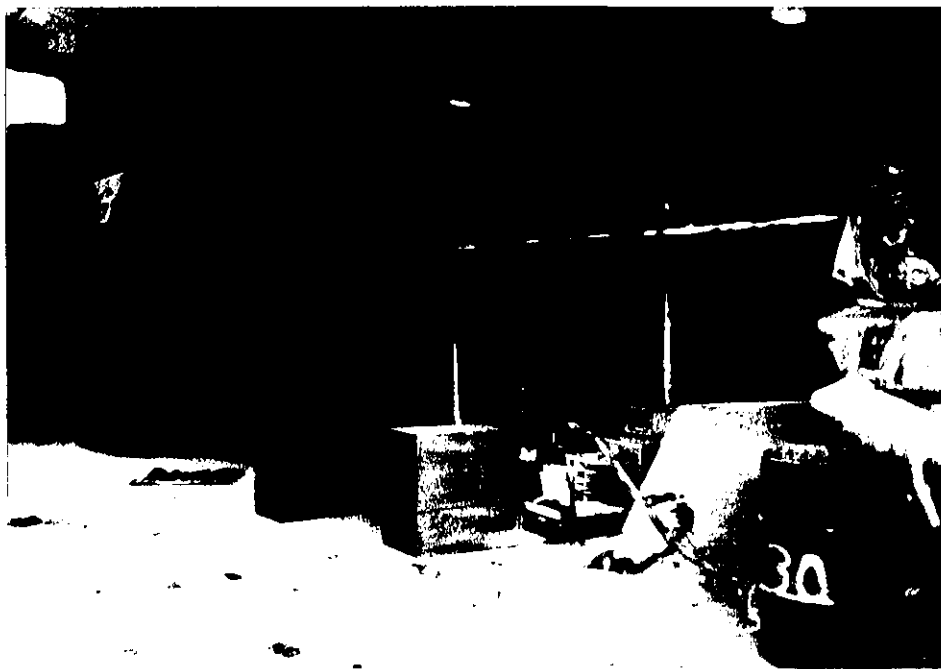
Photograph No. 4

Description: East and south walls; area shown is location at which chemical analysis of waste was performed

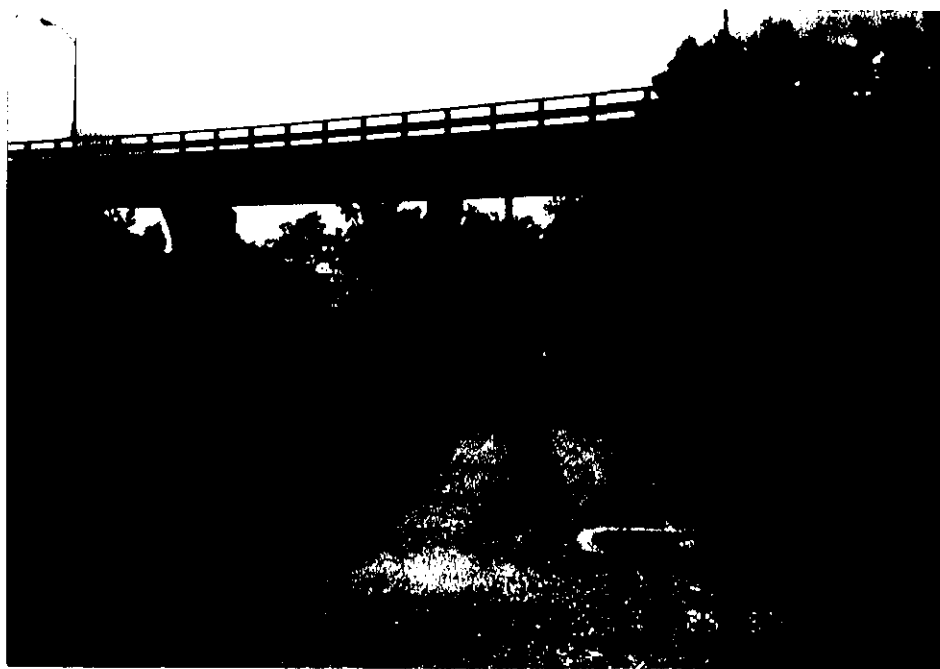
Photograph No. 8
Orientation: East
Description: View of bike path facing old wastewater treatment plant
